Assessing Bank Erosion Affected by Bridges on Goldstream and O'Connor Creek, Alaska

Madelyn Wonderlich (mwonderlich@alaska.edu)
University of Alaska Fairbanks

How do bridges impact stream morphology on local creeks in Fairbanks?

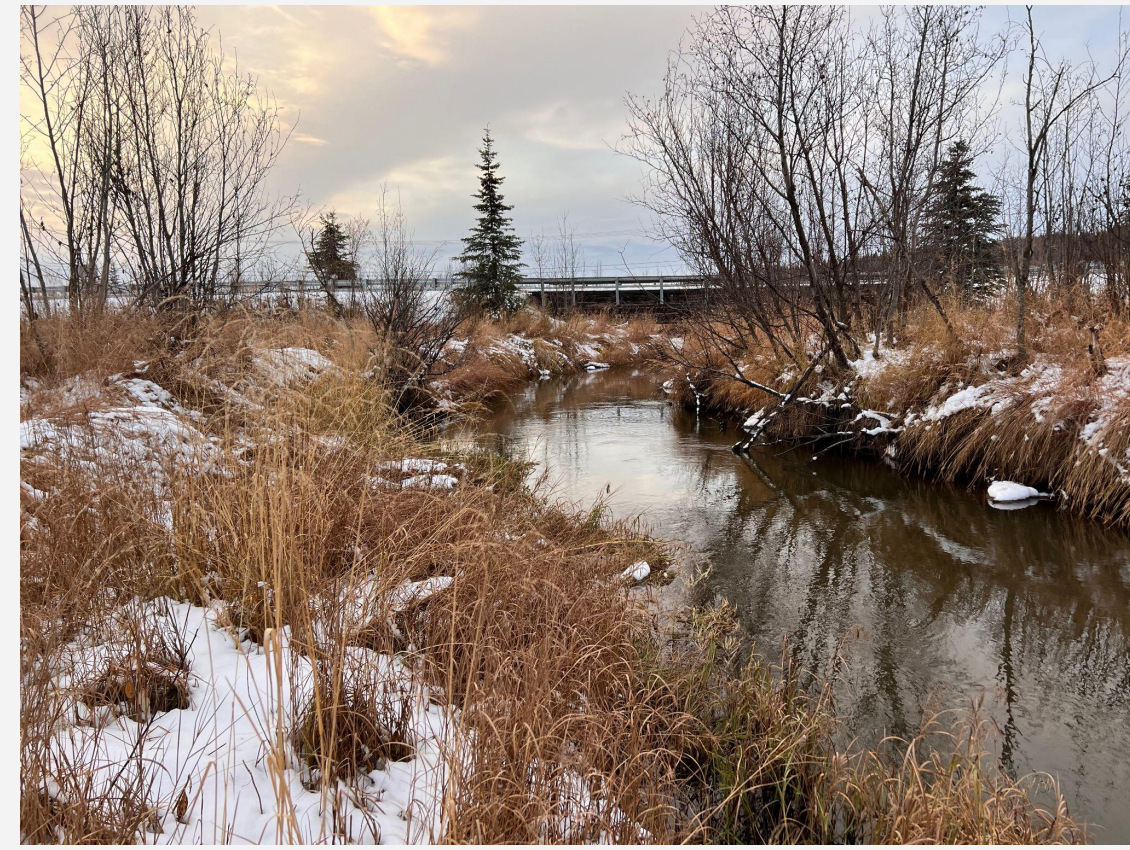
Fig. 3. Goldstream creek, looking upstream towards Ballaine Road and the bridge for Goldstream Creek

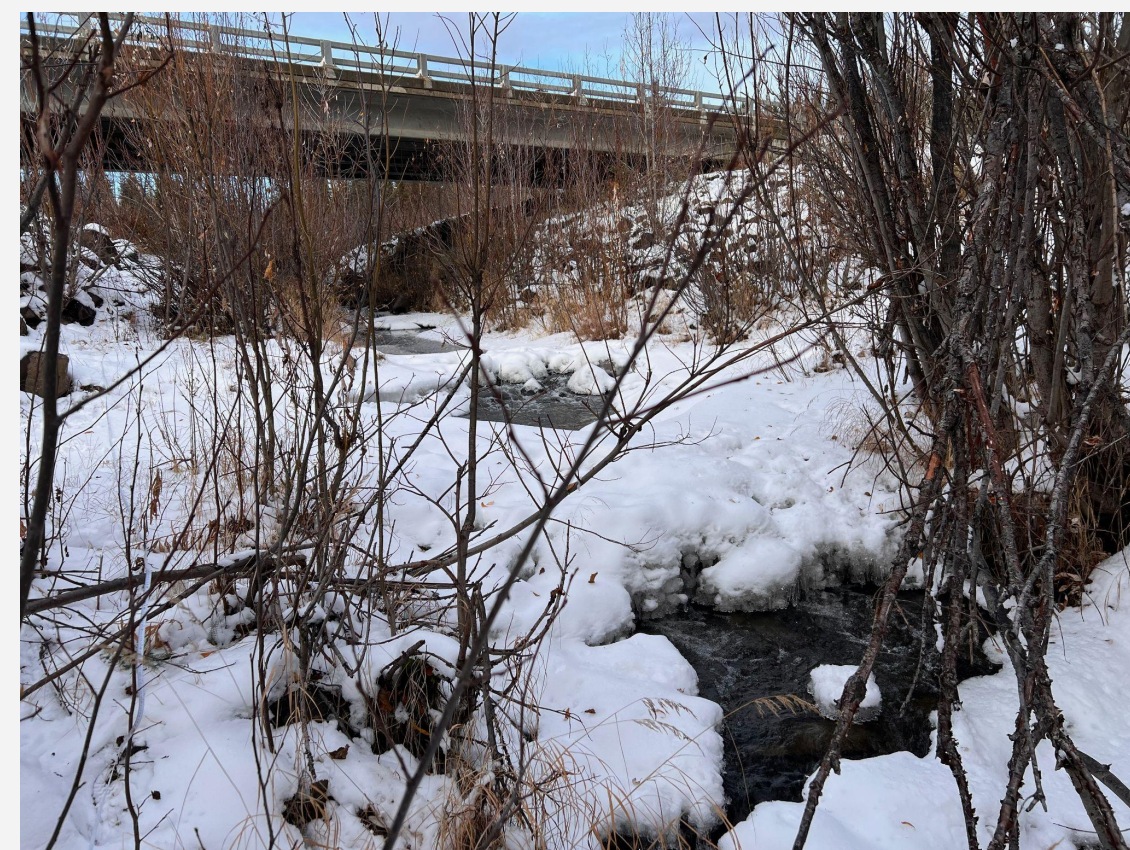
Fig. 4. O'Connor Creek, looking upstream towards Goldstream road and the Bridge for O'Connor Creek

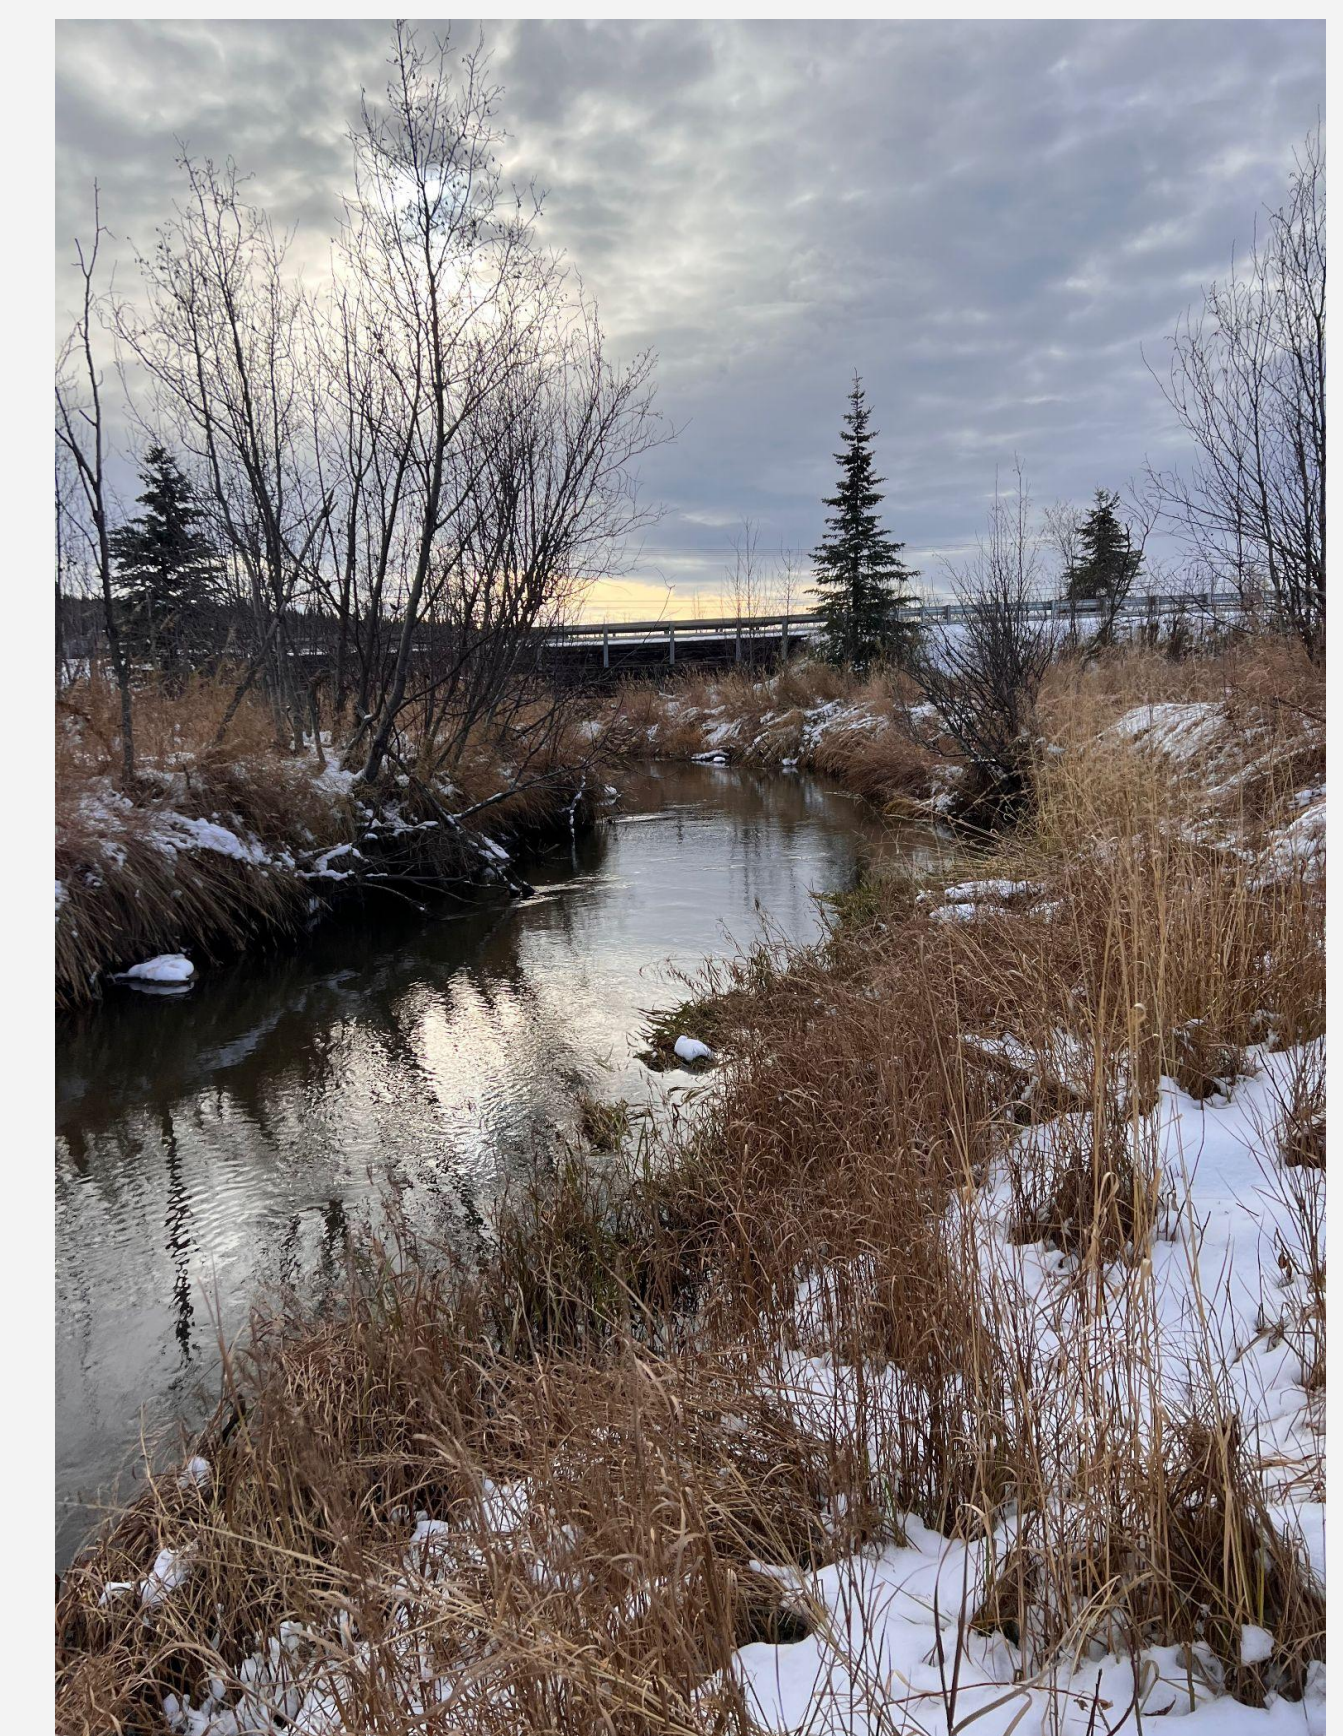
- The overall observations from this study show erosion happening both up and down stream from both O'Connor Creek and Goldstream Creek.
- In both Creeks the BEHI Summary shows steep bank angles, both up and down stream from the bridges.
- Goldstream Creek had significantly more water in wetlands on the upstream side of the bridge than the downstream side. This suggests that bridge is acting like a dam during breakup and causing the water to backup and spill over into its floodplains in high water conditions. (this can be somewhat observed in figure 2)
- O'Connor Creek and Goldstream Creek's bridges were both constructed and worked on about 38 years apart which would likely have an impact on how much they have been able to show signs of erosion and scouring.⁶ With Goldstream Creek having more prominent signs of erosion and changes in stream morphology due to its older age.

Fig. 5. This image shows the eroding bank on Goldstream Creek looking downstream towards the bridge on Ballaine Road.

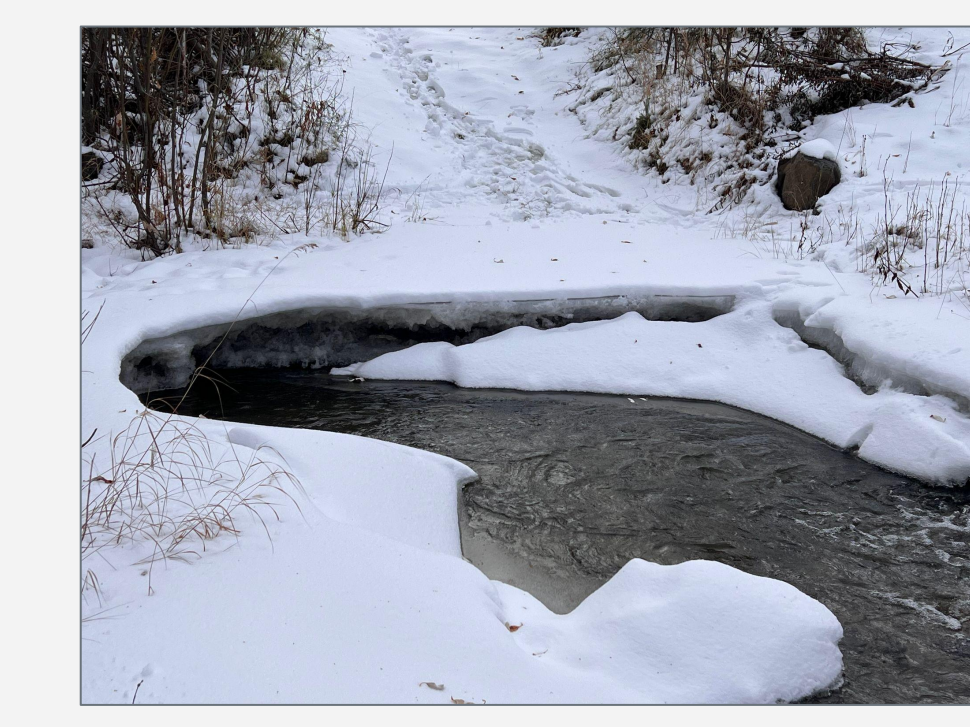
Fig. 6. O'Connor Creek, downstream from the bridge where the multi use trail crosses in the winter when frozen

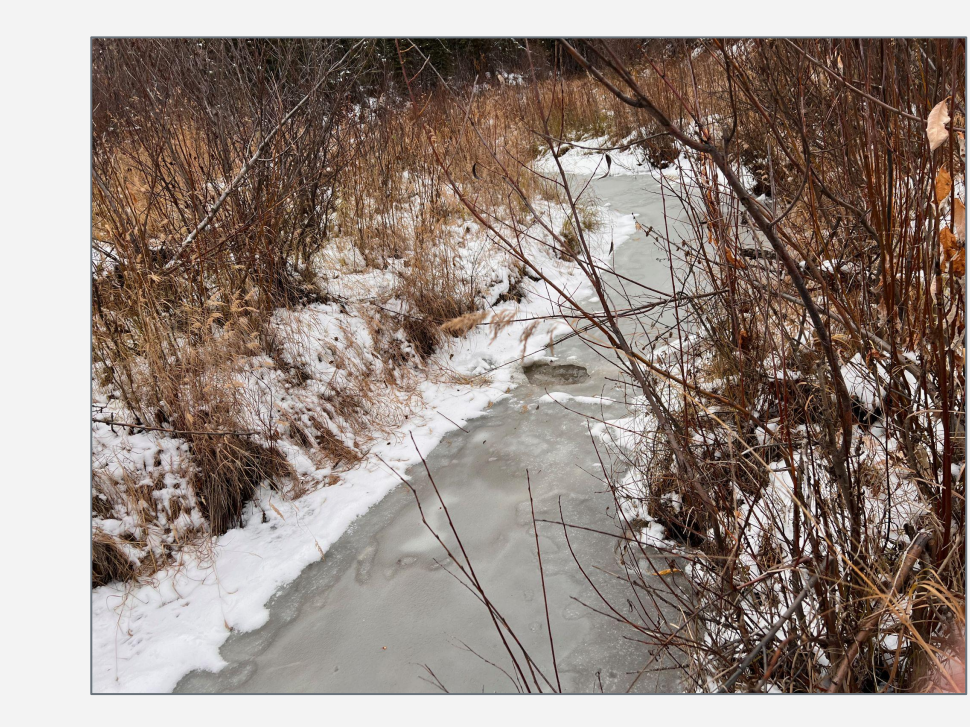
Fig. 7. Upstream from the Bridge on O'Connor Creek, frozen before the bridge below the bridge
