Analysis of the Cripple Creek Restoration Project
Rachel Allen, Maggie House, Susan Glade
University of Alaska Fairbanks
2021

Abstract:

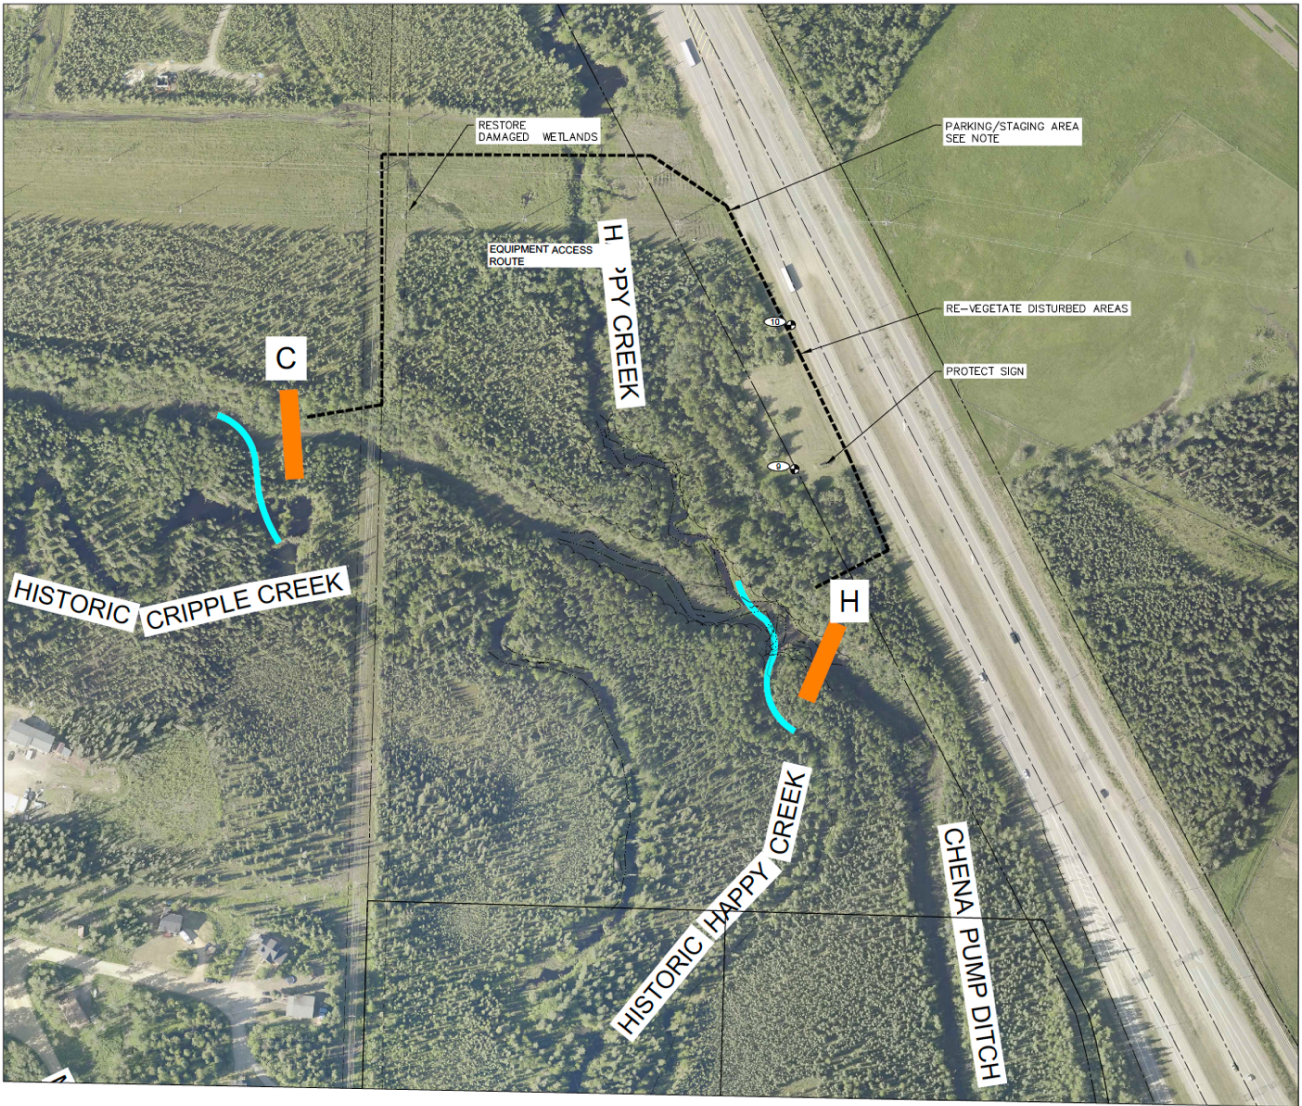
The picture below shows the full Cripple Creek restoration project. The block with the letter "H" is where we conducted most of our research. That is where the confluence of Happy Creek and Cripple Creek is, and that is where the failure occurred. There are spruce and birch trees in this area, and on the bank of the creek there are grasses and other low vegetation. After construction, there is a large area of demolished trees on the north side of the creek. The land that the construction has taken place on is located on the ancestral lands of the Dena people from the Lower Tanana river.

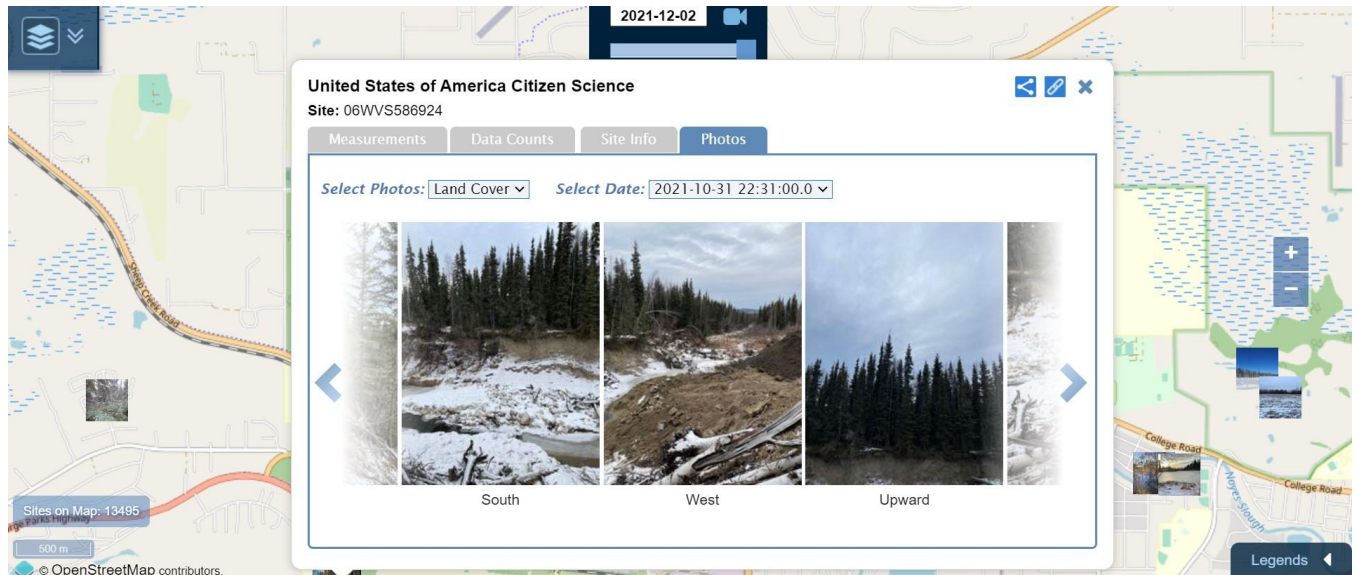
10/31/2021 Land Cover	10/31/2021 Land Cover	10/31/2021 Land Cover

While analysis was done on the information we currently have, the research is still ongoing. When taking land cover observations at the site, it was noticed that the entire bank had washed away from the flood event causing geotech fabric to become exposed. We found through comparing the bank's

slope (at block H) from before the failure to afterwards, the slope went from 22° to 90°. After the reconnection, the creek was 15-20 feet deep. Now, it is only 2-3 feet deep. The site was also cleared of vegetation during construction and there was no sign of regrowth when we visited the site months later.

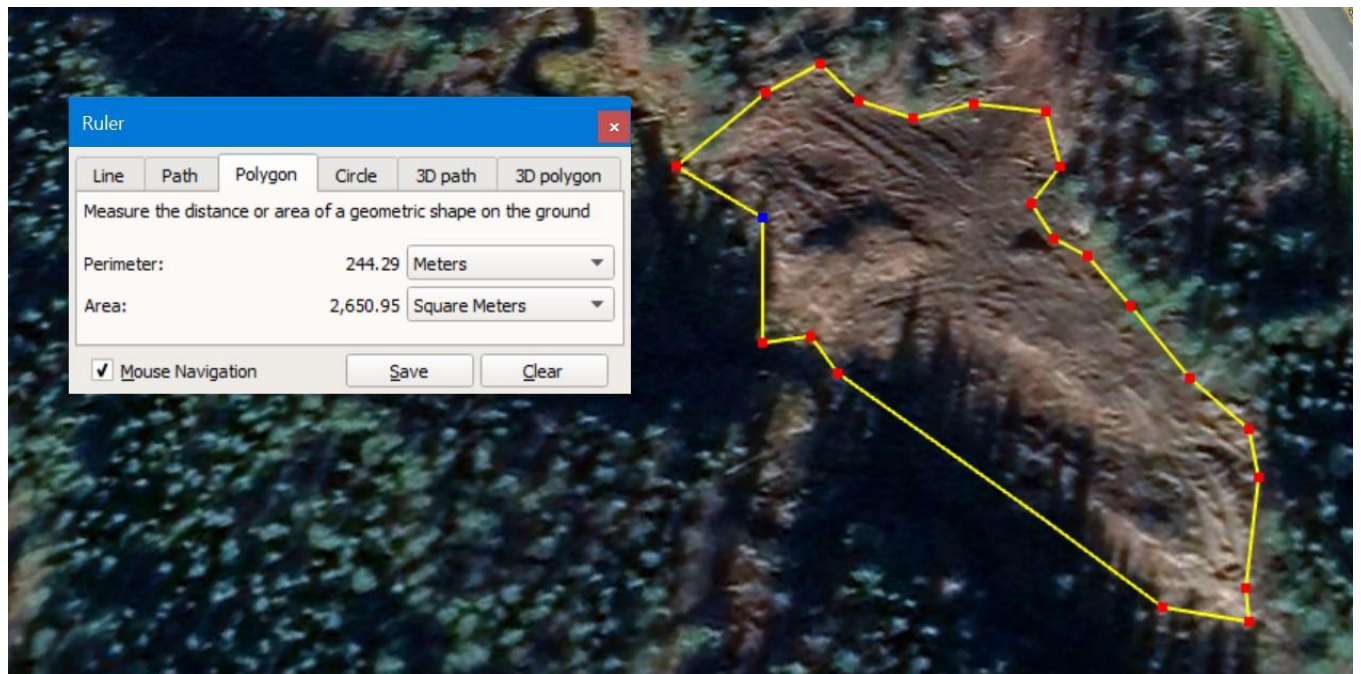
We believe the erosion of the blocks and bank ultimately caused the failure. The streamflow was too fast and cut into the infrastructure. The clearing of land for machinery access is expected to have weakened the bank's stability, causing mass wasting to begin off of the geotech fabric. They cleared roughly 2,650 square meters, shown in the picture below. Due to the type of fabric used to stabilize the bank, the soil didn't have any support to regrow vegetation. Also, as this is a type of slip fabric, it was easy for the soil to continue to 'slip' down the slope and into the drain channel. Evidence of springtime failure of geotextile fabric has been documented. This sediment quickly builds up and can cause a disturbance in the channel's flow and habitat ability. Currently, it is assumed that the weakening of the bank and the erosion of the blocks due to ice build up during spring melt is the reason for the restoration's failure. It is these elements that the engineers are in the process of fixing in order to apply the science to their new, updated plan.
