# Analysis of the Cripple Creek Restoration Project

Rachel Allen, Maggie House,  
Susan Glade  
GLOBE Teacher: Christi  
Buffington  
University of Alaska Fairbanks

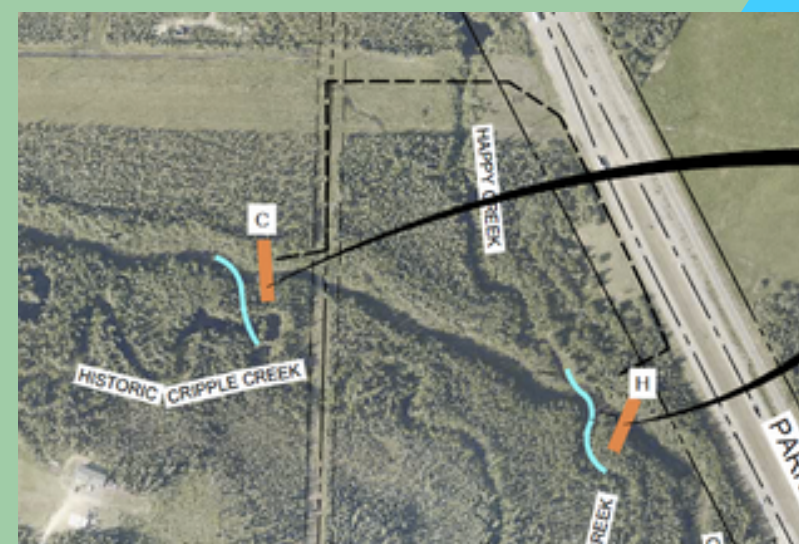
Figure 1. Blocks H and C of Cripple Creek Restoration. Osborne.

While analysis was done on the information we currently have, the research is still ongoing. When taking land cover observations at the site, it was noticed that the entire bank had washed away from the flood event causing geotech fabric to become exposed. We found through comparing the bank's slope (at block H) from before the failure to afterwards, the slope went from 22° to 90°. After the reconnection, the creek was 15-20 feet deep. Now, it is only 2-3 feet deep. The site was also cleared of vegetation during construction and there was no sign of regrowth when we visited the site months later.

We believe the erosion of the blocks and bank ultimately caused the failure. The streamflow was too fast and cut into the infrastructure. The clearing of land for machinery access is expected to have weakened the bank's stability, causing mass wasting to begin off of the geotech fabric. They cleared roughly 2,650 square meters. Due to the type of fabric used to stabilize the bank, the soil didn't have any support to regrow vegetation. Also, as this is a type of slip fabric, it was easy for the soil to continue to 'slip' down the slope and into the drain channel. Evidence of springtime failure of geotextile fabric has been documented. This sediment quickly builds up and can cause a disturbance in the channel's flow and habitat ability. Currently, it is assumed that the weakening of the bank and the erosion of the blocks due to ice build up during spring melt is the reason for the restoration's failure. It is these elements that the engineers are in the process of fixing in order to apply the science to their new, updated plan.

The blocks failed as a result of removing vegetation from the banks of the creek and trying to redirect flow almost 90° and uphill. There was a spillway created in case of flooding. It was supposed to be successful over a 100 year period, but it failed after two months. As of right now, there is work being done to build a dam where the H block used to be. This could be successful at first, however dams only work for a certain amount of years and there is currently no fish infrastructure being built. There is also no guarantee that this dam won't fail the same way that the blocks failed. A better solution would be to build up the banks along Happy and Cripple Creek to redirect flow that way. This would have better long term success without adversely affecting salmon habitats. In this project, we had multiple mentors. Christi Buffington is our teacher for Introduction to Watershed Management, and she helped us throughout the process of this project. She is also the one that introduced us to GLOBE. During our time of research, we met with Mitch Osborne, Peder Nelson, and Chris Arp. All three of these professionals gave us important information and helpful advice.
