Analysis and Study of Coastal Erosion Trend at Rajamangala Beach

Researcher: Nithinant Jantho, Anusik Jaijong and Thanadech Viprakasit

Princess Chulabhorn Science High School, Trang

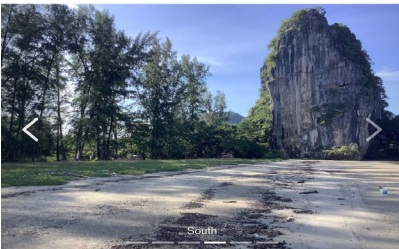
Measured Date:	2024-10-31
Organization Name:	Princess Chulabhorn Science High School Trang
Site ID:	336061
Site Name:	47NNJ338315
Latitude:	7.522302
Longitude:	99.30637
Elevation:	0.8m
Measured At:	2024-10-31T01:53:00
Measurement Latitude:	7.5232
Measurement Longitude:	99.3071
Measurement Elevation:	3
Standing Water:	true
Muddy:	true

Figure4: Land cover Data

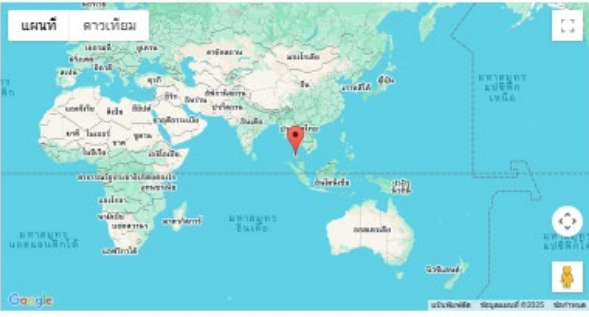
ข้อมูลศึกษา *		
rajamangala beach		
หมายเลขจุดศึกษา 379079		
พิกัด		
ละติจูด *	ลองจิจูด *	ความสูง *
7.554865	99.308206	7.2 เมตร
<input checked="" type="radio"/> ทิศเหนือ	<input type="radio"/> ทิศใต้	<input checked="" type="radio"/> ระดับแนวค
<input type="radio"/> ทิศตะวันตก		
Set elevation		
แหล่งที่มาของข้อมูลศึกษา *		
<input type="radio"/> เครื่องมือวัดทางภูมิศาสตร์		
<input checked="" type="radio"/> อื่น ๆ		
แผนที่

Figure5: Study Site Data
