Assessing Bank Erosion Affected by Bridges on Goldstream and O'Connor Creek, Alaska

Madelyn Wonderlich (mwonderlich@alaska.edu)
University of Alaska Fairbanks

How do bridges impact stream morphology on local creeks in Fairbanks?

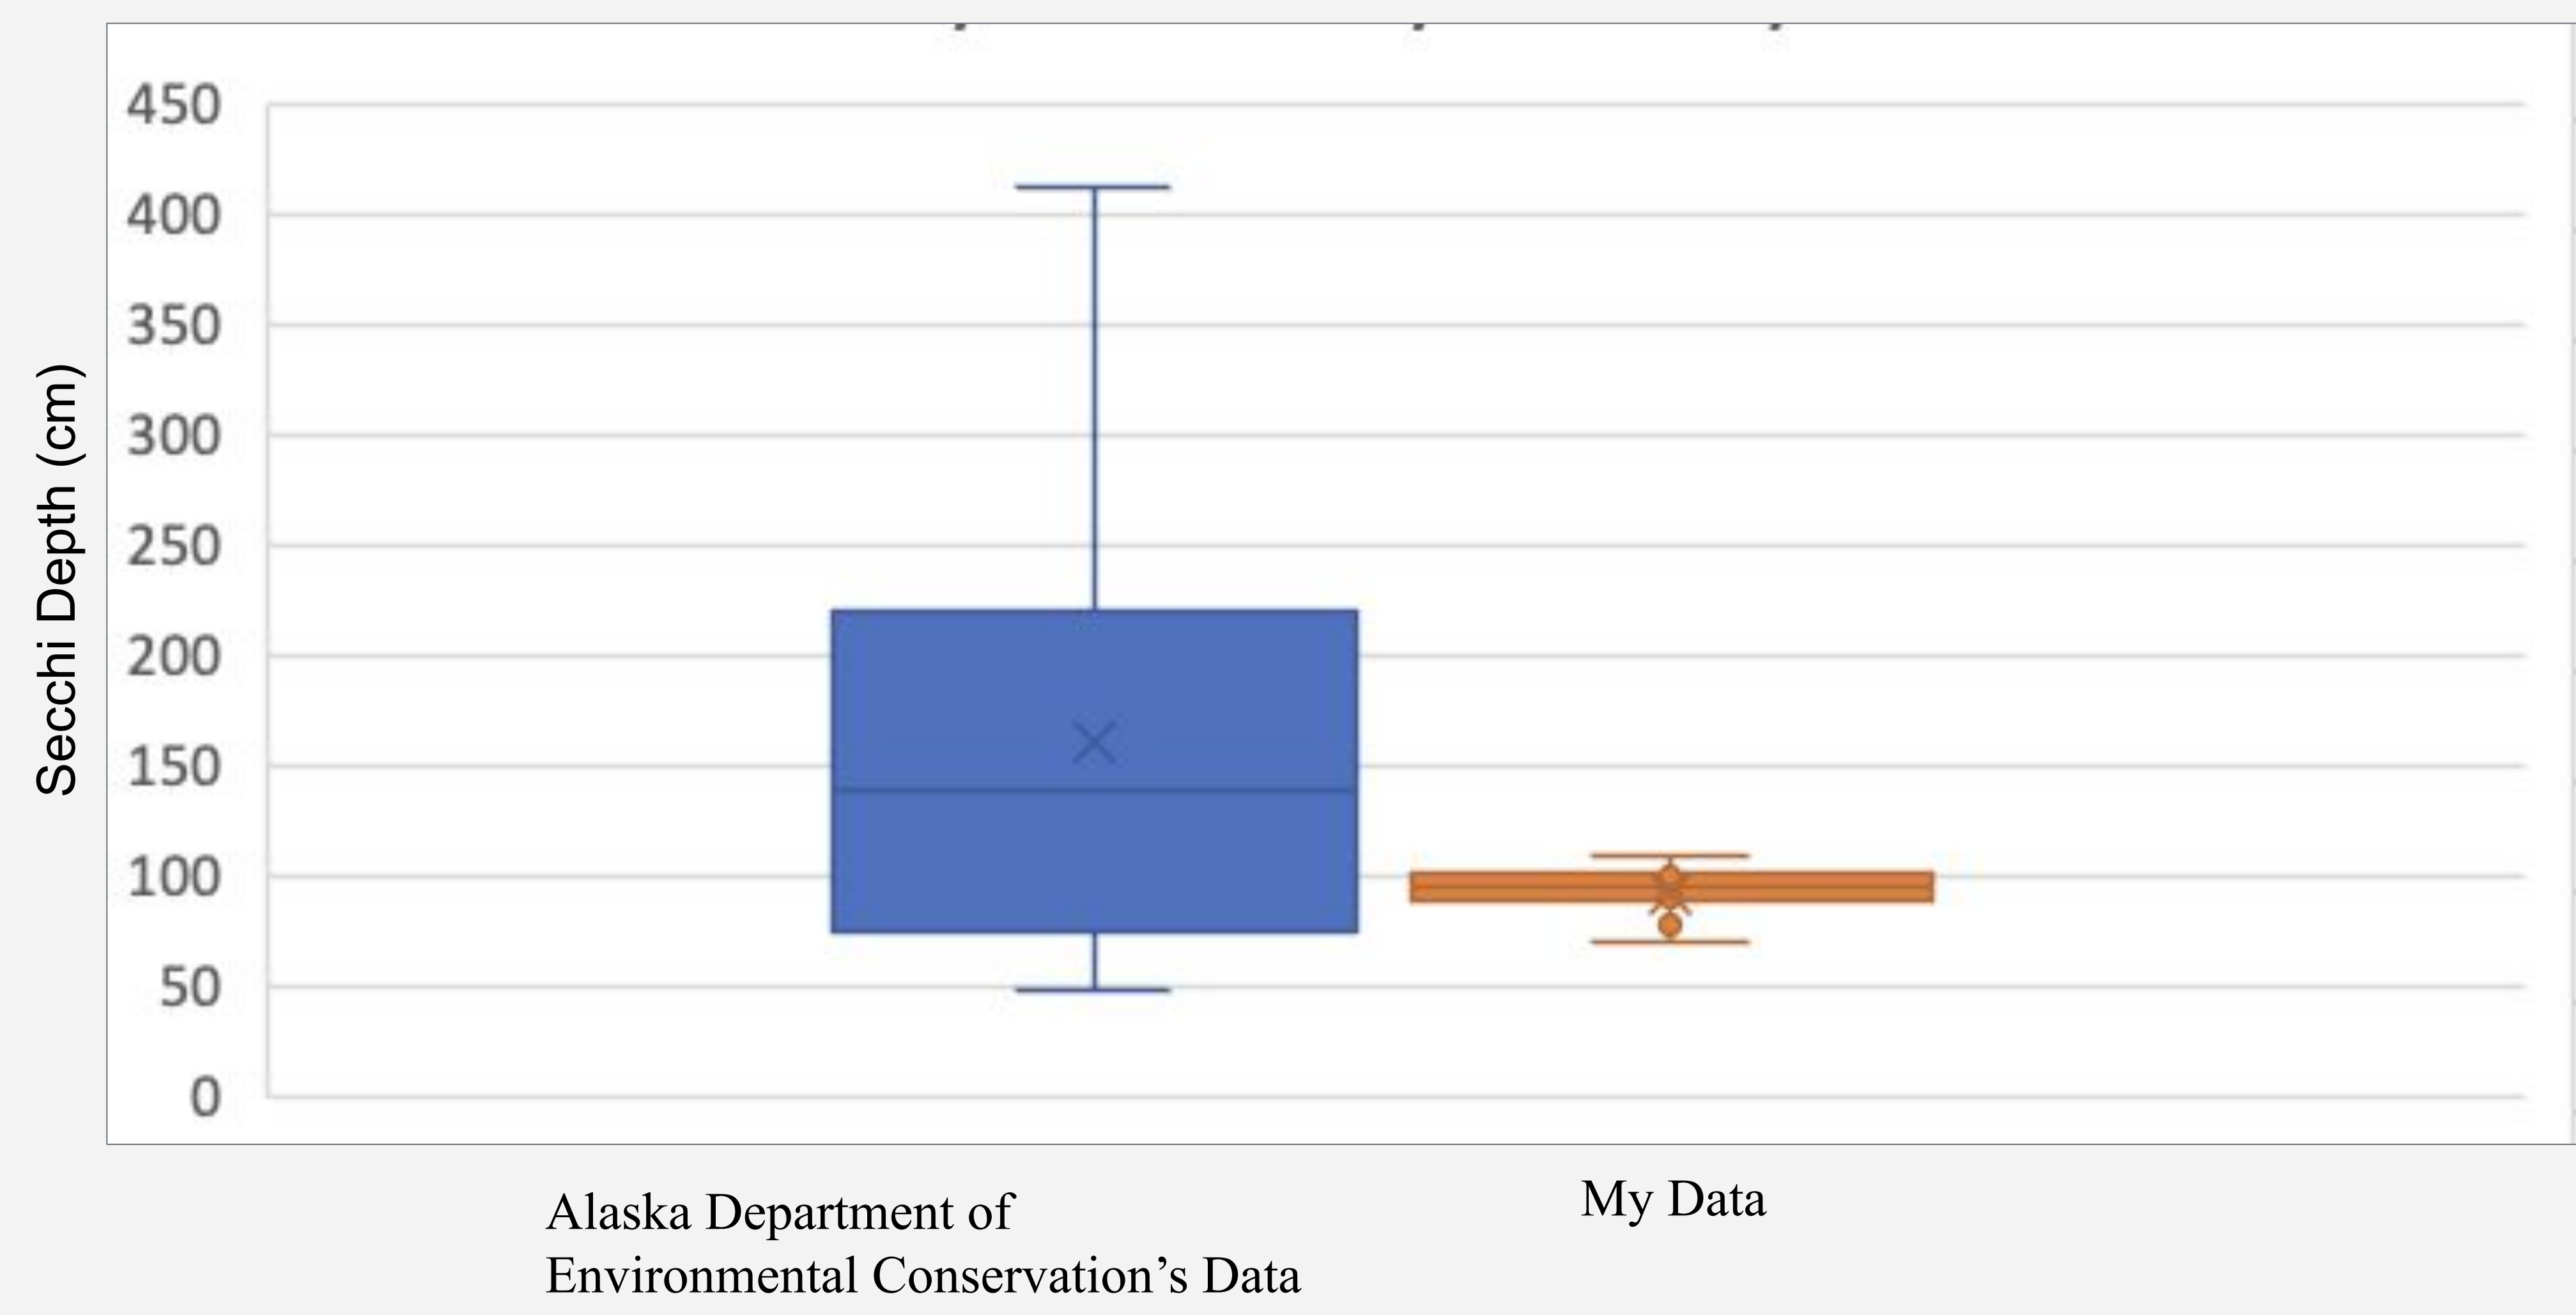
Table 2. Alaska Department of Environmental Conservation Turbidity Data for Goldstream Creek in 2017 vs. my transparency tube data for Goldstream Creek 2023

- The results show that there is very steep bank angles around the bridges on all sites around both of the bridges
- Bank height for Goldstream Creek was 1.8 times higher on average than the bank height for O'Connor Creek
- O'Connor Creek had a higher bankfull height than Goldstream creek on average.
- Both of these sites had silt as their bank material adjustment
- Most of the Data from the Transparency tube fell into an acceptable range according to a table from Penn State. ³
