# Analysis of the Cripple Creek Restoration Project

Rachel Allen, Maggie House,  
Susan Glade  
GLOBE Teacher: Christi  
Buffington  
University of Alaska Fairbanks

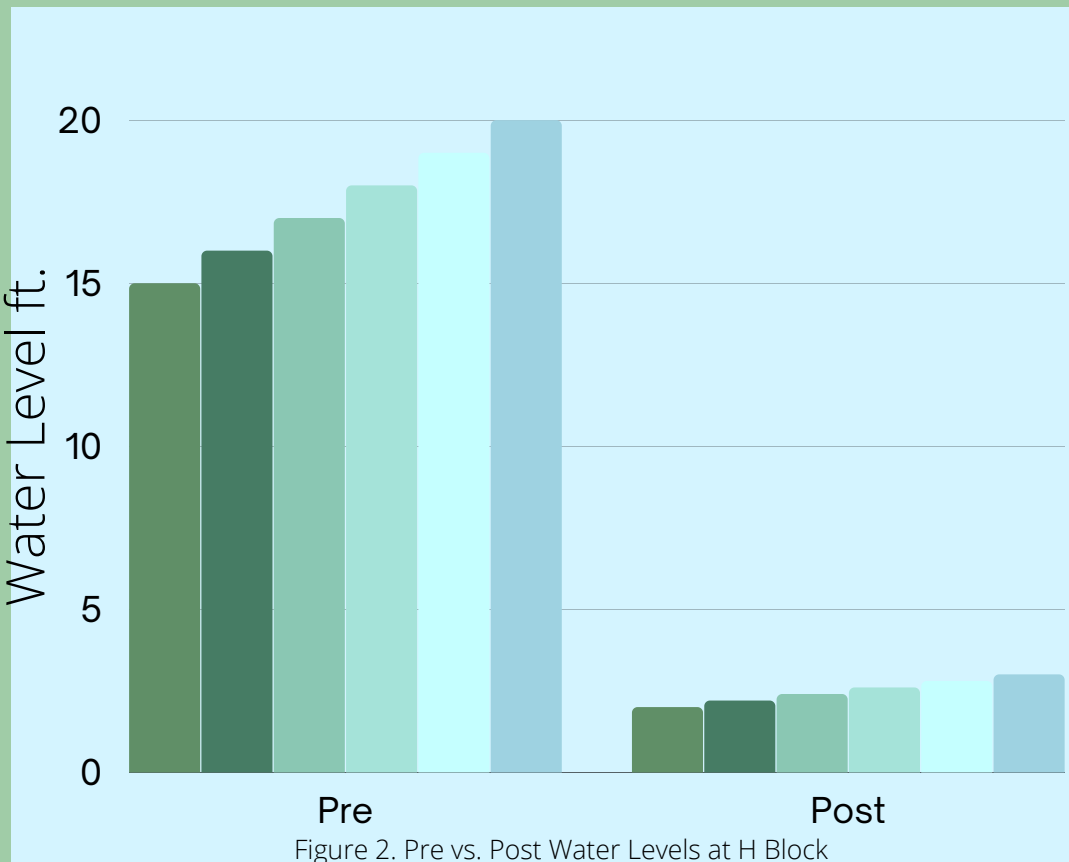
While analysis was done on the information we currently have, the research is still ongoing. When taking land cover observations at the site, it was noticed that the entire bank had washed away from the flood event causing geotech fabric to become exposed. We found through comparing the bank's slope (at block H) from before the failure to afterwards, the slope went from 22° to 90°. After the reconnection, the creek was 15-20 feet deep. Now, it is only 2-3 feet deep. The site was also cleared of vegetation during construction and there was no sign of regrowth when we visited the site months later.

We believe the erosion of the blocks and bank ultimately caused the failure. The streamflow was too fast and cut into the infrastructure. The clearing of land for machinery access is expected to have weakened the bank's stability, causing mass wasting to begin off of the geotech fabric. They cleared roughly 2,650 square meters. Due to the type of fabric used to stabilize the bank, the soil didn't have any support to regrow vegetation. Also, as this is a type of slip fabric, it was easy for the soil to continue to 'slip' down the slope and into the drain channel. Evidence of springtime failure of geotextile fabric has been documented. This sediment quickly builds up and can cause a disturbance in the channel's flow and habitat ability. Currently, it is assumed that the weakening of the bank and the erosion of the blocks due to ice build up during spring melt is the reason for the restoration's failure. It is these elements that the engineers are in the process of fixing in order to apply the science to their new, updated plan.

Figure 3. Pre vs. Post differences in Bank Slope at H Block
