GLOBE Regional Learning Expedition 2022

The effect of Käsnu harbour on water characteristics

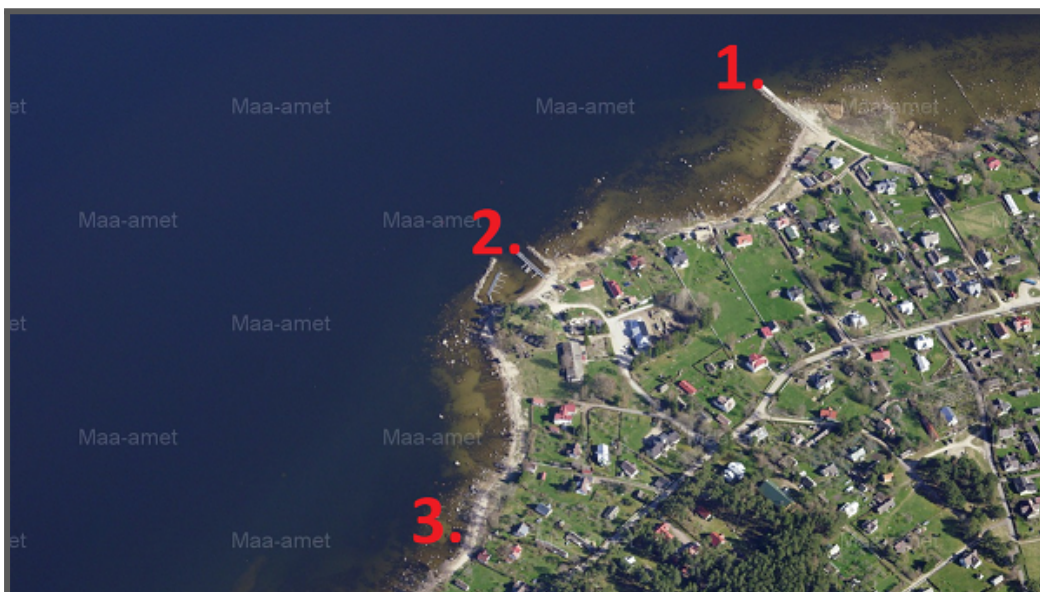
Figure 2. Map of research and measuring locations. First is Käsnu pier, second is Käsnu harbour and the third is Käsnu stone beach. Source: Estonian Land Board

We did fieldwork at the research locations and analysed the water samples on 3 August 2022 from 2:00 PM to 6:30 PM. We measured in Käsnu, Estonia (Figure 1 and 2) at three locations - Käsnu pier, Käsnu harbour and Käsnu stone beach. The locations were all 300 metres from each other.

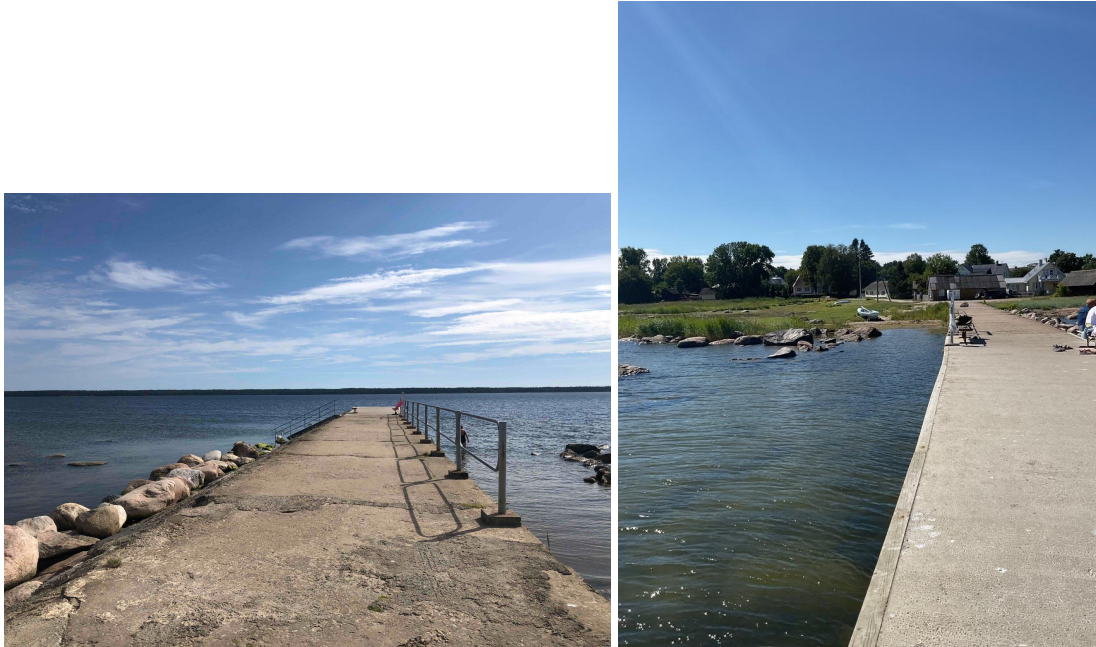
Figure 3. The first research site: Käsnu pier

The first location was Käsnu pier (Figure 3). The air temperature at the pier was 22°C, the water temperature was 19°C and there was a strong wind. The shore was rocky and there was sand on the beach. The vegetation on the shore was mainly reed and other plants. The seabed was sand and mixed sediments.

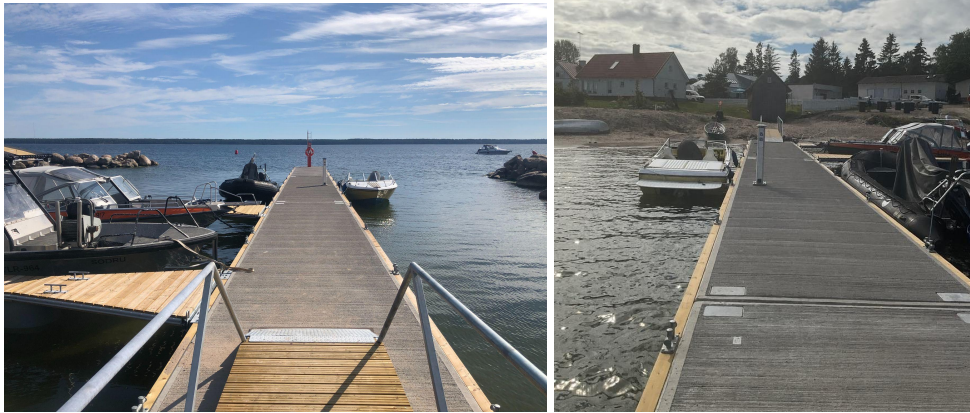
Figure 4. The second research site: Käsmu harbour

The second location was Käsnu harbour (Figure 4). The air temperature at the harbour was 23°C, the water temperature was 20°C and there was a breeze. There was no rain and the water transparency was more than 120 cm. The shore was sandy, the harbour was surrounded by boulder fences. The vegetation at the shore was mainly birch and pine. The seabed was a mix of sand and sediments.

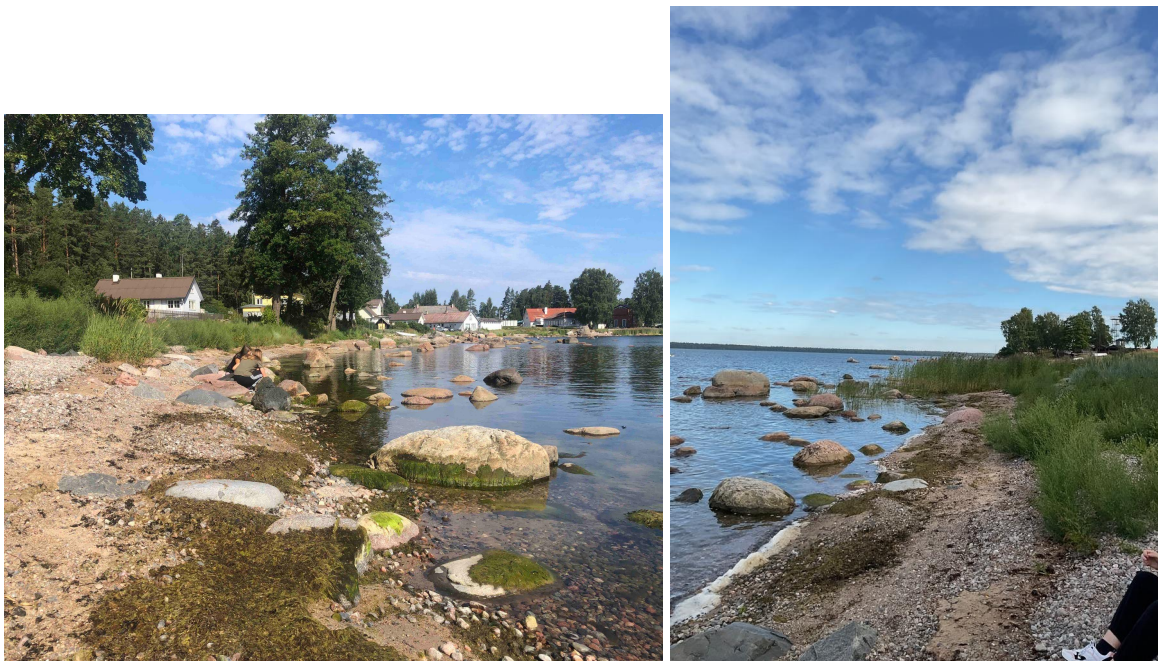
Figure 5. The third research site: Käsmu stone beach

The third location was a beach covered in stones (Figure 5). Since it doesn't have an official name, we named the location as Stone beach. The air temperature in the stone beach was 21°C, the water temperature was 21°C and there was a small breeze. The shore was a mix of pebbles and sand. There were boulders on the shore and in the sea. The seabed was a mix of sand and sediments.

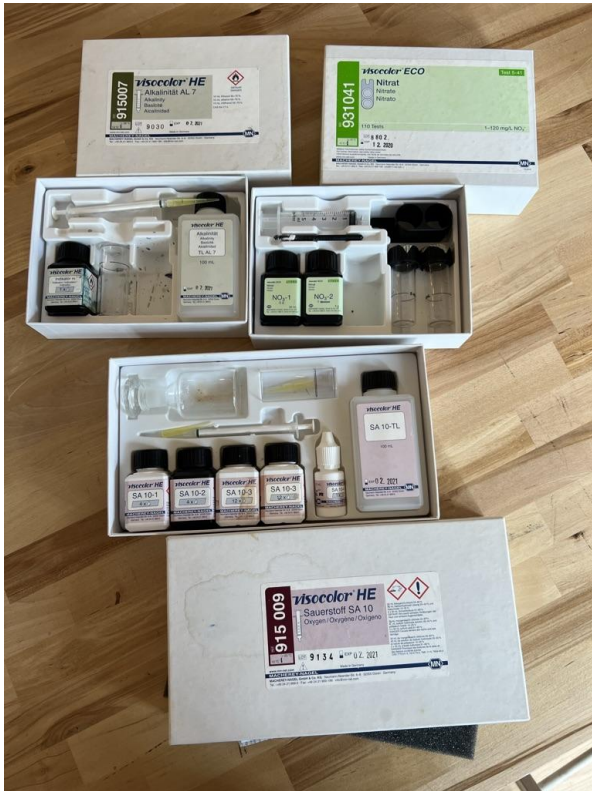
Figure 6. Kits for measuring alkalinity, nitrates and dissolved oxygen

For our research we used GLOBE hydrology protocols: temperature, transparency (with the transparency tube), dissolved oxygen, conductivity, pH, alkalinity, and nitrates. The equipment we used for alkalinity, nitrates and dissolved oxygen can be seen in Figure 6. Measuring process can be seen on Figure 7.

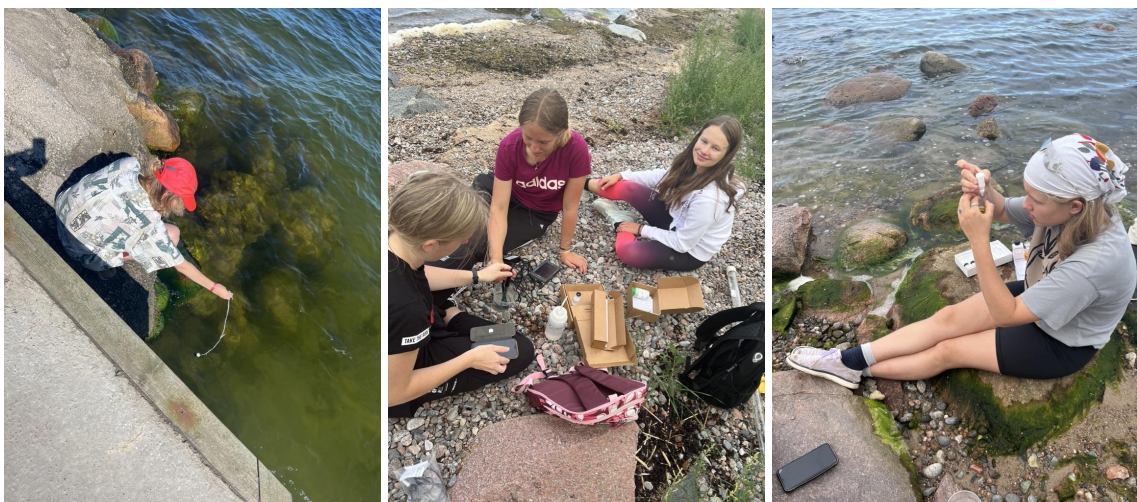
Figure 7. Measuring process
